CHANSON, H. (2003). "Stability of Concrete Macro-Roughness Linings for Overflow Protection of Earth Embankment Dams. Discussion." *Can J of Civ. Eng.*, Vol. 30, No. 3, pp. 601-604 (ISSN 0315-1468).

## **Stability of Concrete Macro-Roughness Linings for Overflow Protection of Earth Embankment Dams (1) - Discussion**

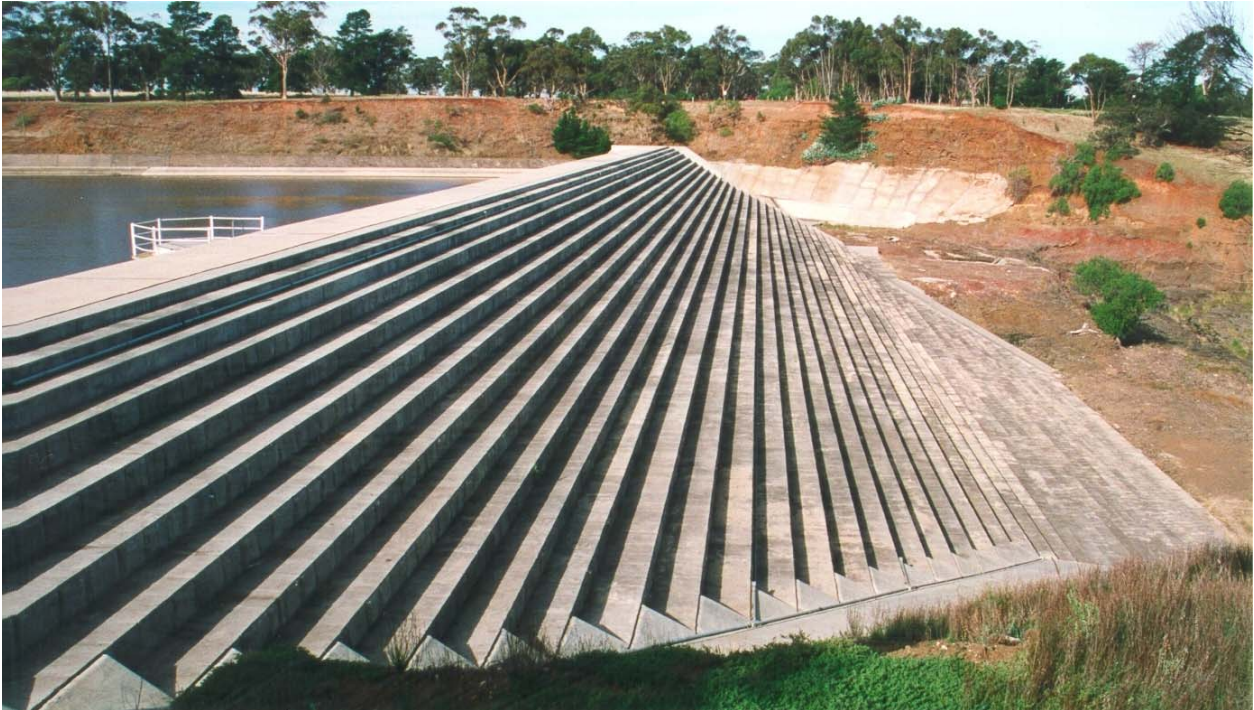
**Fig. 1** - Photographs of embankment dam stepped spillways

(a) Melton dam secondary spillway on 30 January 2000 - Completed in 1916, the Melton dam was equipped in 1994 with a secondary spillway ( $Q_{des} = 2,800 \text{ m}^3/\text{s}$ ,  $h = 0.6 \text{ m}$ )

During the last two decades, a number of embankment dam spillways were designed with concrete overtopping protection shaped in a stepped fashion (Chanson 2001 pp. 220-230). During the 1990s, the construction of secondary stepped spillways accounted for nearly two-thirds of dam construction in USA (Ditchey and Campbell 2000). The preferred construction method was roller compacted concrete overlays placed on the downstream slope. Figure 1 presents two examples. Figure 1a shows the Melton dam secondary spillway completed in 1994. With a discharge capacity  $Q_{des} = 2,800 \text{ m}^3/\text{s}$ , it is the world's largest embankment stepped spillway (Chanson 2001, pp. 221-223). Figure 1b shows a newer embankment dam designed and built with a secondary stepped spillway system ( $Q_{des} = 481 \text{ m}^3/\text{s}$ ). While most research on stepped spillway hydraulics focused on steep chutes for gravity dams ( $\alpha \sim 50^\circ$ ), recent studies brought new insights into the complicated overflow hydrodynamics (Chanson and Tombes 2001,2002, Gonzalez 2003).

- (a) Melton dam secondary spillway on 30 January 2000 - Completed in 1916, the Melton dam was equipped in 1994 with a secondary spillway ( $Q_{des} = 2,800 \text{ m}^3/\text{s}$ ,  $h = 0.6 \text{ m}$ )
- (b) Choctaw 8A dam auxiliary spillway (Courtesy of Craig Savelle and USDA Natural Resources Conservation Service) ( $Q_{des} = 481 \text{ m}^3/\text{s}$ ,  $h = 0.61 \text{ m}$ ,  $B_{crest} = 51.8 \text{ m}$ )

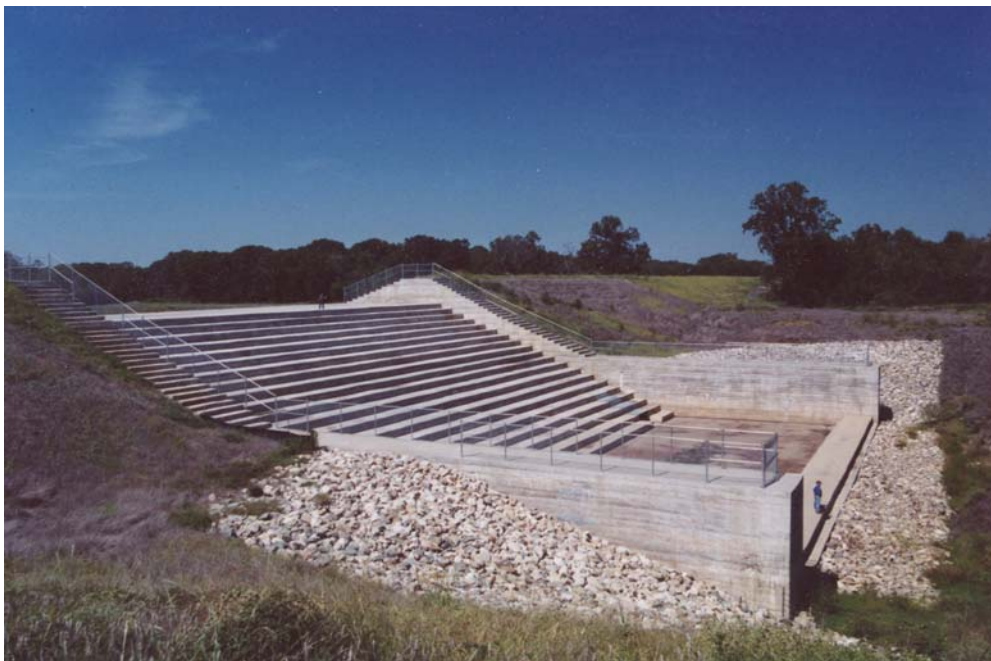
(b) Choctaw 8A dam auxiliary spillway (Courtesy of Craig Savela and USDA Natural Resources Conservation Service) ( $Q_{des} = 481 \text{ m}^3/\text{s}$ ,  $h = 0.61 \text{ m}$ ,  $B_{crest} = 51.8 \text{ m}$ )

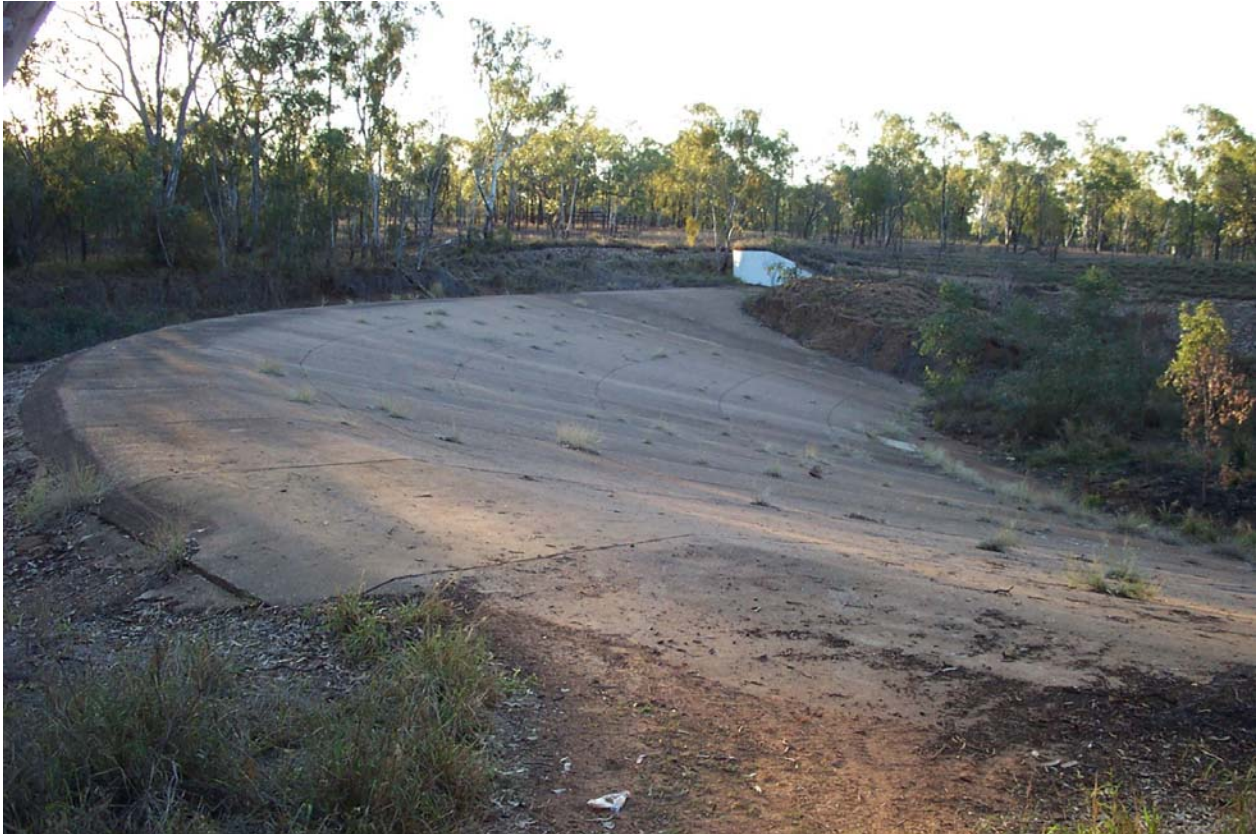
**Fig. 2** - Photographs of Minimum Energy Loss weirs

(a) Sandy Creek weir at Clermont (Qld, Australia 1963) - Dam height: 6.1 m,  $Q_{des} = 850 \text{ m}^3/\text{s}$ ,  $B_{crest} = 116 \text{ m}$  - View from the right bank on 3 Sept. 2002 (Courtesy of Keith James)

A very different concept of overflow embankment spillway is the Minimum Energy Loss (MEL) weir design. The concept of MEL weir was developed by late Professor Gordon R. McKay (1913-1989) to pass large floods with minimum energy loss, hence with minimum upstream flooding. The first MEL weir design was the Sandy Creek weir at Clermont (Qld, Australia 1962) (Fig. 2a). The largest, Chinchilla weir (Qld, Australia 1973), is listed as a "large dam" by the International Commission on Large Dams (Fig. 2b). A MEL weir is typically curved in plan with converging chute sidewalls and the overflow spillway chute is relatively flat (Fig. 2). The downstream energy dissipator is concentrated near the channel centreline away from the banks. The inflow Froude

number remains low and the rate of energy dissipation is small compared to a traditional weir. For example, both Clermont and Chinchilla weirs were designed to give no afflux at design flow  $Q_{des}$ . In 1974, the Chinchilla weir passed  $1,130 \text{ m}^3/\text{s}$  with a measured afflux of less than 100 mm (Turnbull and McKay 1974). Ideally a MEL weir could be designed to achieve critical flow conditions at any position along the chute and, hence, to prevent the occurrence of a downstream hydraulic jump (Chanson 1999, pp. 418-419). This is not always achievable because the variations of the tailwater flow conditions with discharge are often important. MEL weirs are typically earthfill structures and the spillway section is protected by concrete slabs. Construction costs are minimum. A major inconvenient is the overtopping risk during construction : e.g., Clermont weir in April 1963, Chinchilla weir twice in 1972 and 1973. In addition, an efficient drainage system must be installed underneath the chute slabs.

- (a) Sandy Creek weir at Clermont (Qld, Australia 1963) - Dam height: 6.1 m,  $Q_{des} = 850 \text{ m}^3/\text{s}$ ,  $B_{crest} = 116 \text{ m}$  - View from the right bank on 3 Sept. 2002 (Courtesy of Keith James)
- (b) Chinchilla weir (Qld, Australia 1973) - Dam height: 14 m,  $Q_{des} = 850 \text{ m}^3/\text{s}$ ,  $B_{crest} = 410 \text{ m}$  - View from the right bank on 8 Nov. 1997

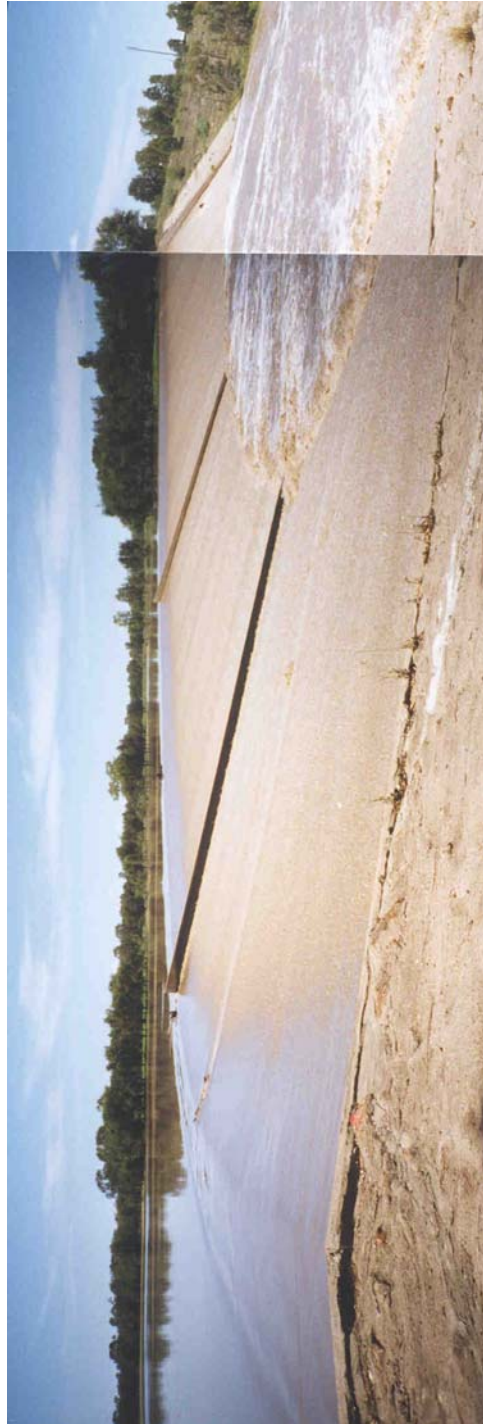
**Fig. 2** - Photographs of Minimum Energy Loss weirs

(b) Chinchilla weir (Qld, Australia 1973) - Dam height: 14 m,  $Q_{des} = 850 \text{ m}^3/\text{s}$ ,  $B_{crest} = 410 \text{ m}$  - View from the right bank on 8 Nov. 1997
